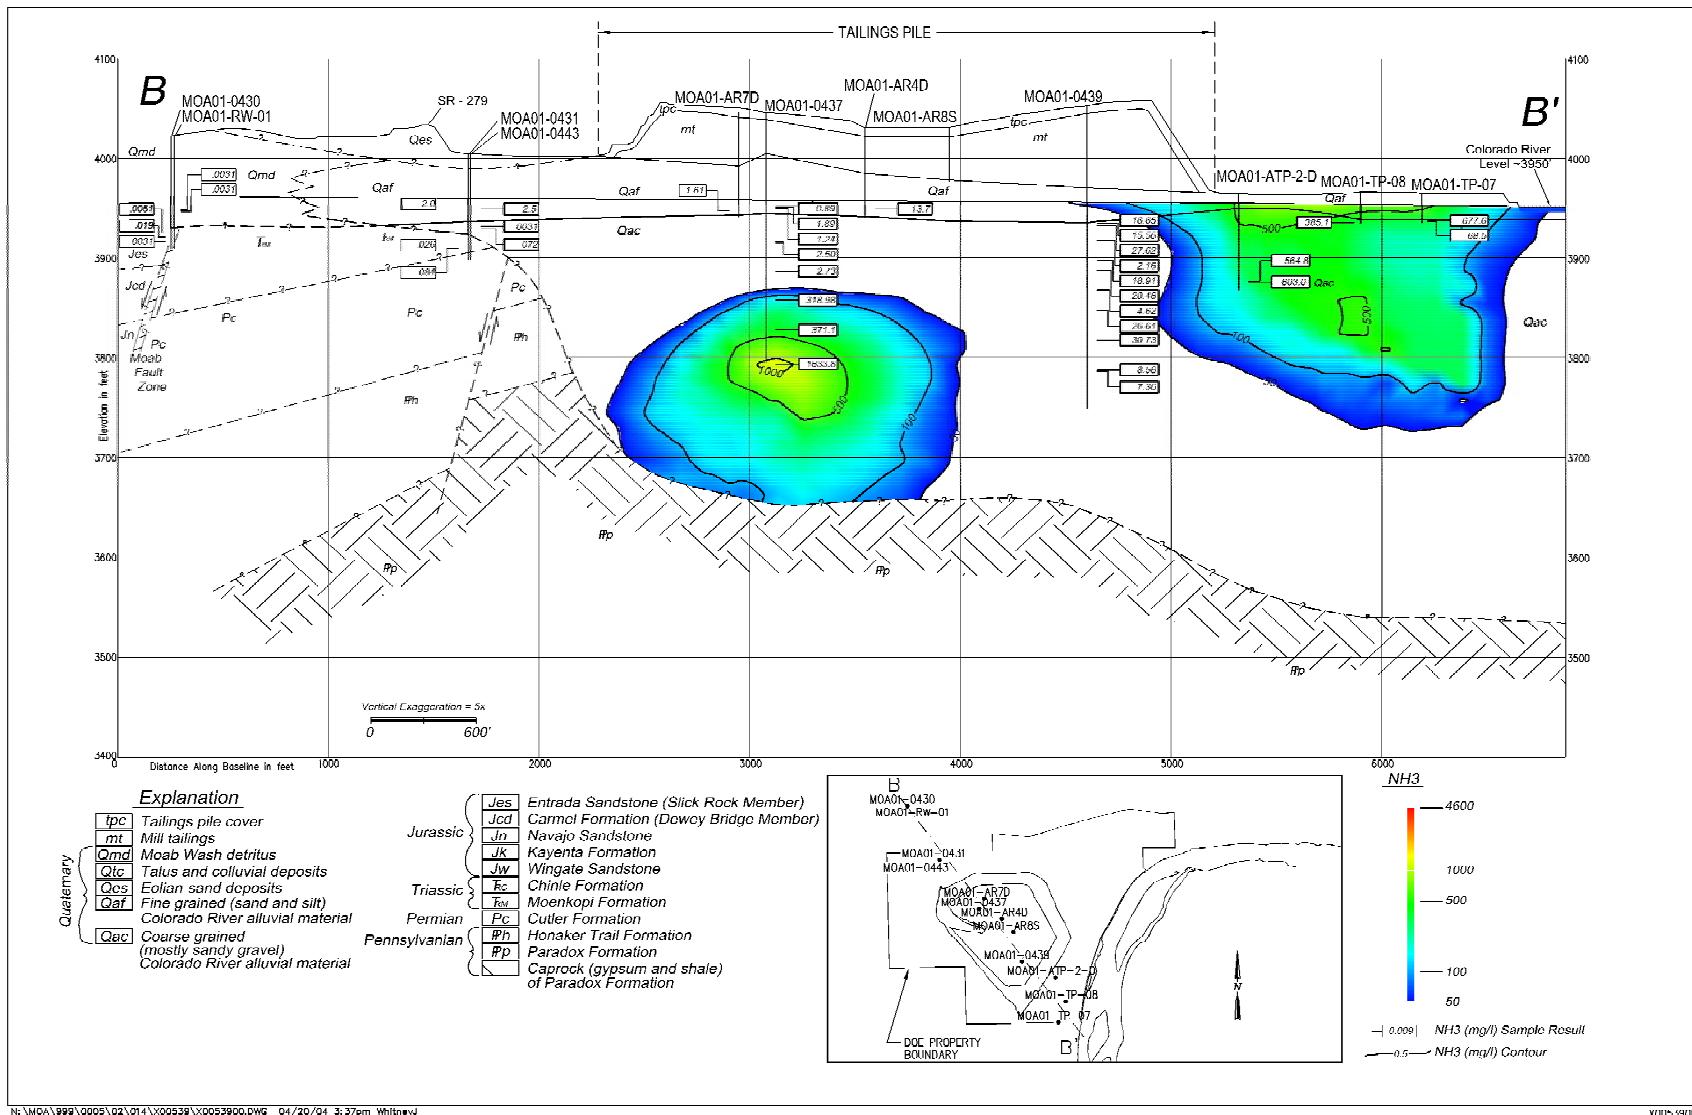
Figure 3-12. Cross-Sectional View of Ammonia Concentrations Beneath the Tailings Pile
